Investigation of timber bridges

Alar Just
Tallinn University of Technology
Tallinn, Estonia

During this research, inspections on 17 timber bridges in Estonia were conducted by authors of this paper in the autumn of 2014. The study was ordered by the Estonian Road Cluster and was performed by SP Technical Research institute of Sweden and Tallinn University of Technology.

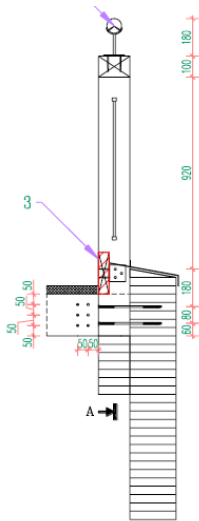
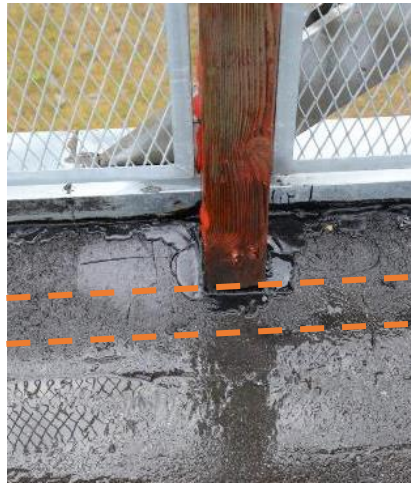
Designed solution

Built solution

The damage was caused by non-ventilated joints between deck plate and main girder. Deck was covered by water tight layer and asphalt. In contradiction with the designed solution, the support area at the edges of wooden deck plate was also covered by asphalt and the drying of wood of the deck plate at the edges was blocked. The water barrier shown in red in Figure 3 was missing.

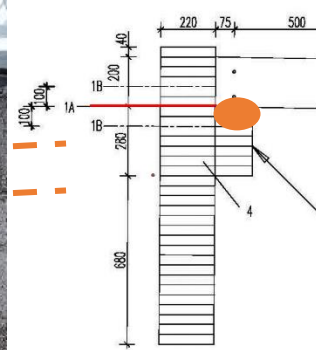
Fungal damage

Inspection showed that the bridges' superstructure is in fair to poor condition. Six of the glulam members in the girders were in poor condition and should be replaced. The moisture content was very high in the beams below the deck plate. Most of the glulam beams had just minor fungal decay, isolated to the upper 100-300 mm of the beam. Deck was seriously damaged by fungal decay along the edges. Part of the deck was completely rotten and collapsed. See Figure 4.

Recovering of damages of the bridge should consist of the replacement of deck structure and replacement of at least two glulam beams (hit by the collapse). The bridge owner – Estonian Road Office – decided to demolish this bridge and build a new steel-concrete bridge instead.

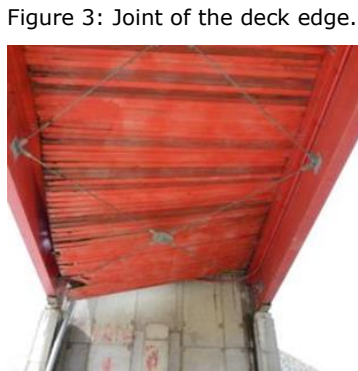
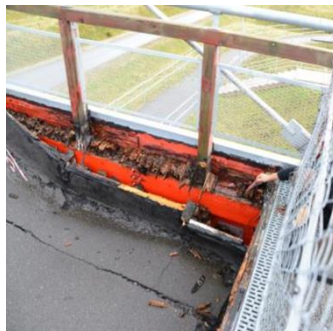
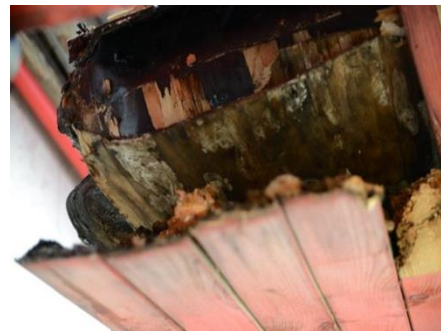
Figure 4: Collapse of the deck in 2014 due to completely rotten deck at supports.

All wooden parts of Vaida footbridge except pylons were made of unimpregnated spruce (*Picea Abies*) instead of chemically treated pine (*Pinus Silvestris*). Unimpregnated spruce does not have noticeable durability without proper cladding.

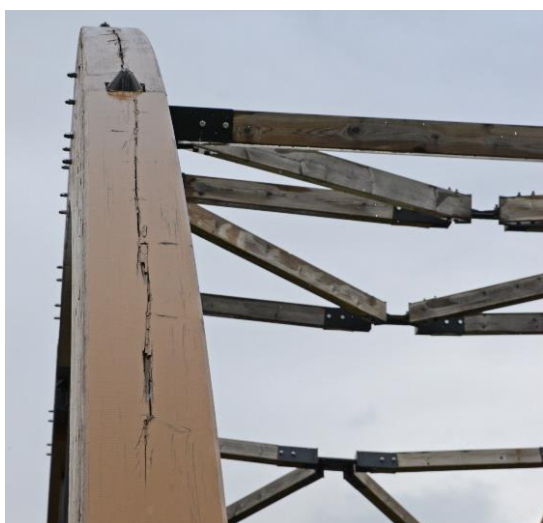
The bridges' superstructure is in very good condition. There is no cladding, sheet metal or other wood protection on the arches or other parts of the super structure. The moisture content in the glulam, is very high close to the bearings, over 25%. The moisture content will remain very high until all weather exposed parts are covered with cladding.

The paint on wooden parts is in poor condition on the south sides. See Figure 6.

Figure 6: Arches are uncovered. Some cracks discovered on the upper side.

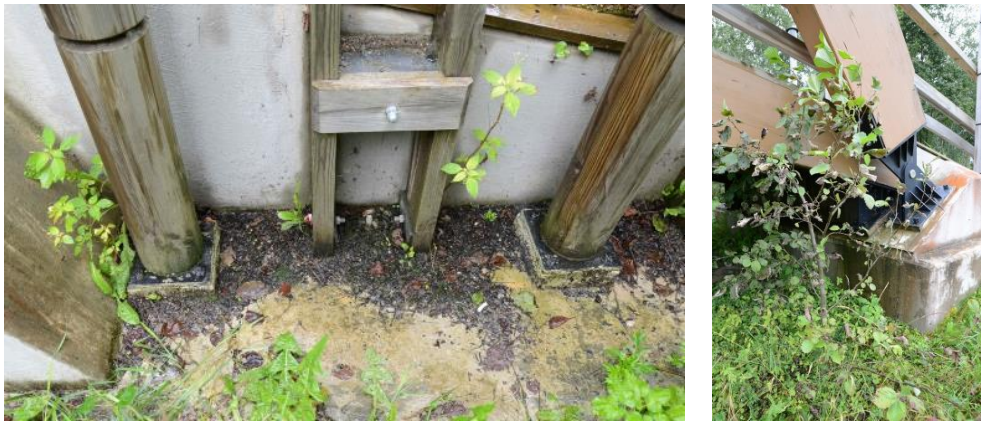
During the inspection the poor maintenance has been recorded. At the supports there were dirt and gravel as well as vegetation discovered close to the timber load bearing elements. With some preventative maintenance, the bridge will be in excellent condition.

Figure 7: Dirt and gravel on all parts of the substructure due to lack of preventative maintenance.

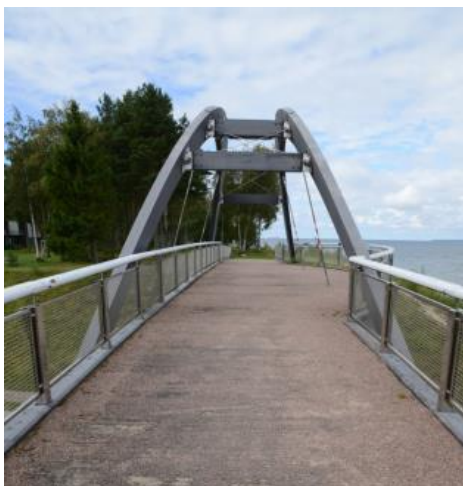
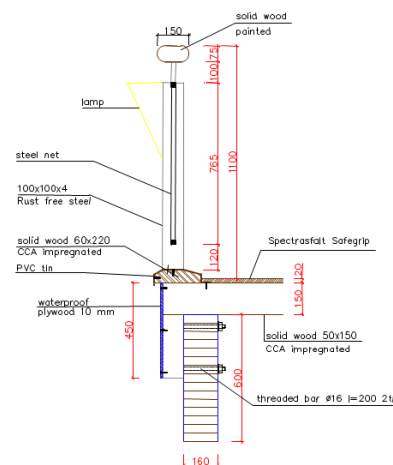
Figure 9: View of the bridge and deck edge detail.

The inspection discovered that the bridges' superstructure was in a serious condition. Probably the dark colour of the new paint led to cracks and allowed the water insertion into the wood. Drying of wood was blocked and that led to development of fungal damage in the arches and cross-beams.

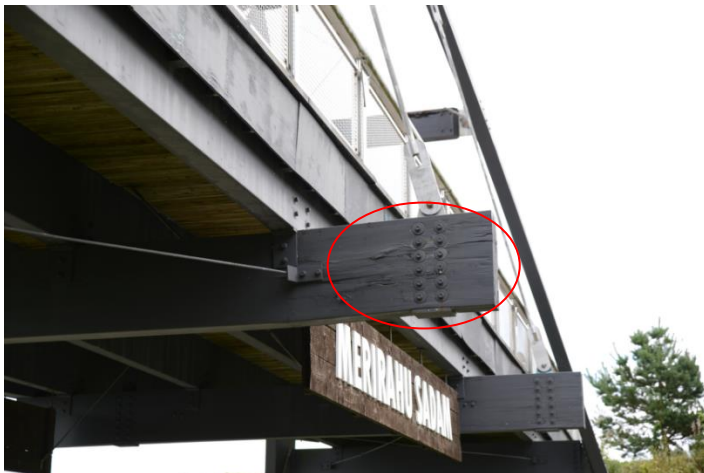
The most critical damage is severe decay and deformation in one transversal beam. The beam was considered as fracture critical during the inspection. The transversals condition is beyond corrective action due to decay in connecting points and along the upper quarter of all sides. See Figure 10.

Fungal damage of the transversal beam

Recovering of damages of the bridge should consist of the replacement of two arches and transversal beams. Paint should be removed from the remained structural elements and replaced with the proper protection systems including wooden or steel claddings on the surfaces exposed to direct weathering.

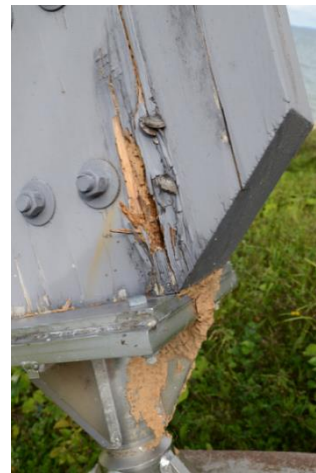
Condition of two arches was beyond corrective action due to decay at supports. The arches were in fair to poor condition and the south east side was recommended to be replaced. The moisture content was high, 20-24% and the decay process could continue until the arches are covered with cladding. The arches are made of spruce. These problems could have been avoided with chemically treated arches and/or protective cladding.

Rotten zone and insects in the arch foot

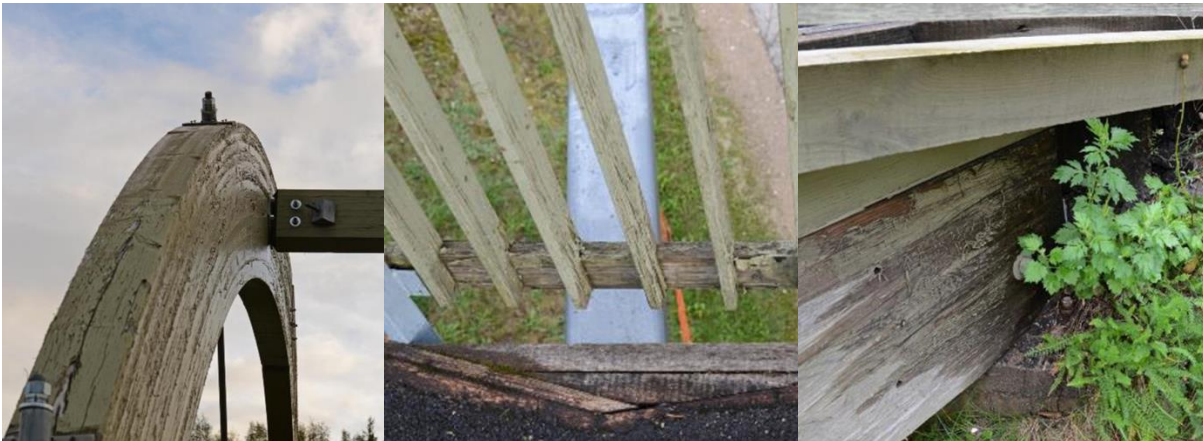
Figure 12: Main findings during the inspection.

Inspection showed that the bridges' superstructure was in good condition. The most critical damage was severe decay and lost parts of the railing that was in an imminent failure condition. All parts made of wood needed to be replaced. The railing was noticed to be relatively low 0,98 – 1,06 m. Some railing posts were tilted out from the bridge. Fasteners used in the railing were very small and weak.

Arches were in satisfactory condition and will need a cladding. The moisture content in the glulam, close to the abutments, was very high, 23-37%. The moisture content will remain very high until all weather exposed parts are covered with cladding. Abutments were affected by increased humid environment from plants and earth. See Figure 12.

Arches need re-painting and covering on top

Railing needs replacement

Bridge girders are in contact with ground and need cleaning

The bridge should have been re-painted years ago. There is no cladding, sheet metal or other wood protection on the arches or other parts of the super structure. With some preventative maintenance, the bridge should have been in much better condition.

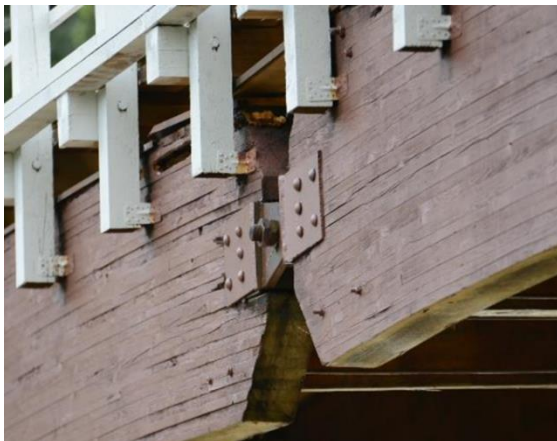
The inspection showed that bridges' superstructure was in very poor condition and the bridge should be closed to traffic. The arches have recently been re-painted and some minor repairs have been done. The arches condition was beyond corrective action due to decay in connecting points and along both bottom, top and outer side of the arches.

Deformation and decay in the top of the arch, the hinge is lost.

The owner of the bridge made a renovation of the bridge at 2016 consisting making new larger steel plates to extend arch top and foot connections to the undamaged wood.

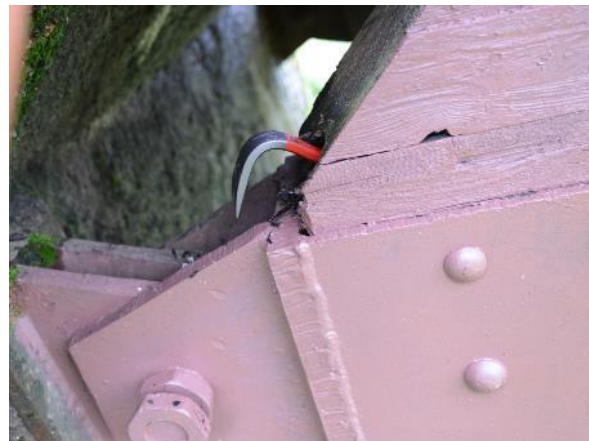
Decay at the support of the arch.

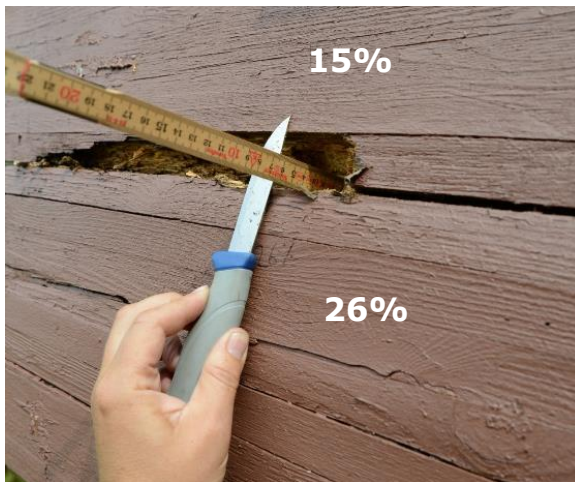
Moisture content, measured on the bridge was between 15 and 30%. The difference between the moisture content above and below the crack in the paint is shown in Figure 15 on the left. The paint did not allow wood to dry out. Water that entered the crack was collected below the crack and could lead to invisible fungal damage inside the wooden element. The risk is that finally the damaged part of the beam does not have any strength left. The region where the crack can be formed cannot be predicted. The proper paint system that allows wood drying is therefore very important.

Moisture contents measured above and below the crack.

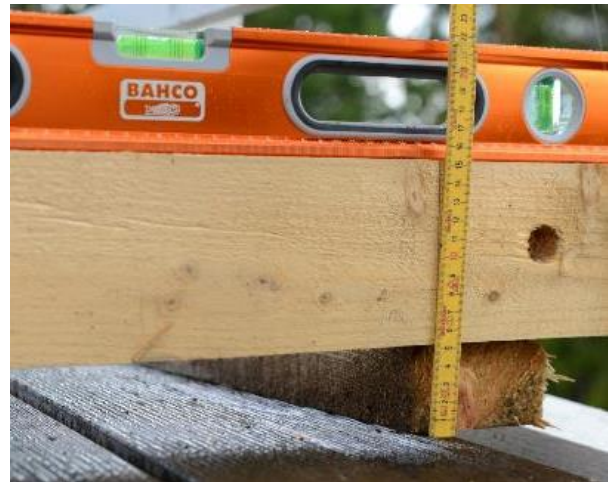
The arches are made of pine, not treated, and were in very bad condition. The top of the bridge was approximately 100mm lower at the east side than the west side. See Figure 15 on the right. This tilt was caused by deformation in connecting points. The deformation was a result of decay in the joints of glulam arches.

Bridge deck tilted 52mm /m, due to local failure in the arches connection points.
