*Andrew Lawrence  
Associate  
Arup Technology & Research  
London, United Kingdom*

## **Building bridges - from Scandinavia to the USA**

# Building bridges - from Scandinavia to the USA

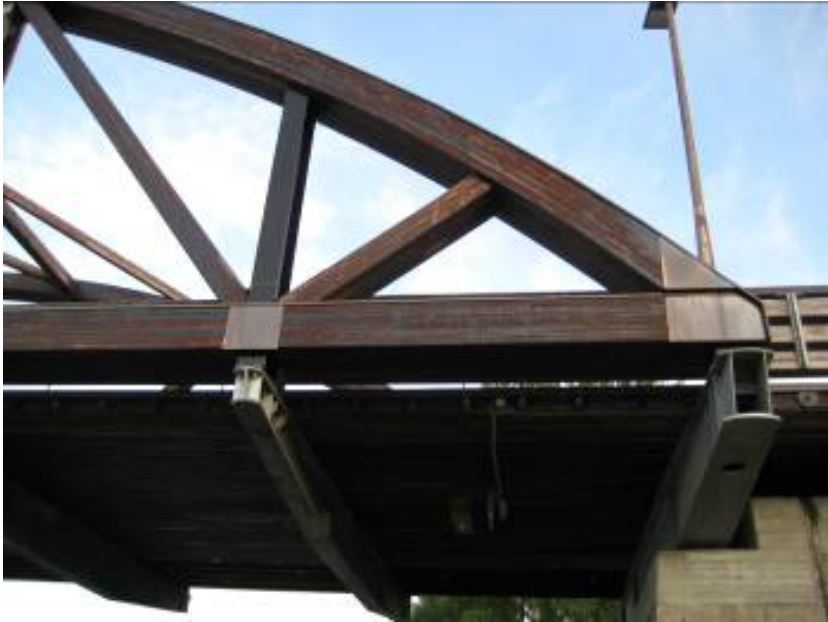
Figure 1: Typical construction of Norwegian bridges showing stress-laminated deck spanning between steel U frames supported off the main arches

The Norwegian bridges have all been built by Moelven, and generally follow similar principles with stress-laminated decks spanning between steel U frames which restrain out of plane buckling of the main structural timber arches (Figure 1). Clear spans up to 70m have recently been achieved (Figure 2).

The Norwegian stress-laminated decks generally use span:depths of about 20, with typical spans of 5m between U frames (Figure 1). Prestressing rods are spaced at 600crs and the initial prestress of about  $1\text{N/mm}^2$  is based on Canadian practice. Point wheel loads are assumed to be spread over a 600mm width of deck based on the Australian Codes. Since the decks are formed from sawn creosote impregnated planks, moisture contents generally start at 20%, and about 30% loss of prestress has generally been found to occur as this drops to the typical 12% in service moisture content. Rods are generally retightened one year after installation, and to date no further tightening has been necessary. Lateral vehicle loads are taken via an engineered steel connection (Figure 4) from the deck diaphragm back into the abutments below. The Norwegian Military Road Bridge (Figure 5) incorporates a concrete deck to avoid damage from tank caterpillar tracks.

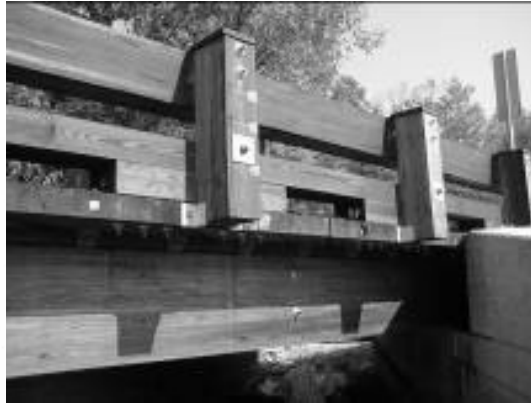
Figure 3: Common American bridge with glulam stringers and transverse glulam deck

The American bridges are generally shorter simply supported spans, either stress-laminated, or more commonly comprising glulam deck panels spanning between longitudinal glulam beams (Figure 3).

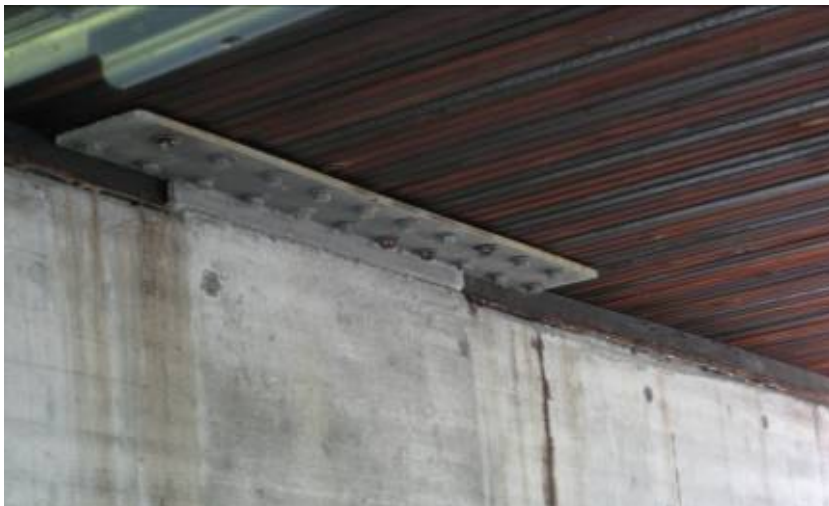
Figure 4: An engineered connection is used to resist lateral loads on the deck

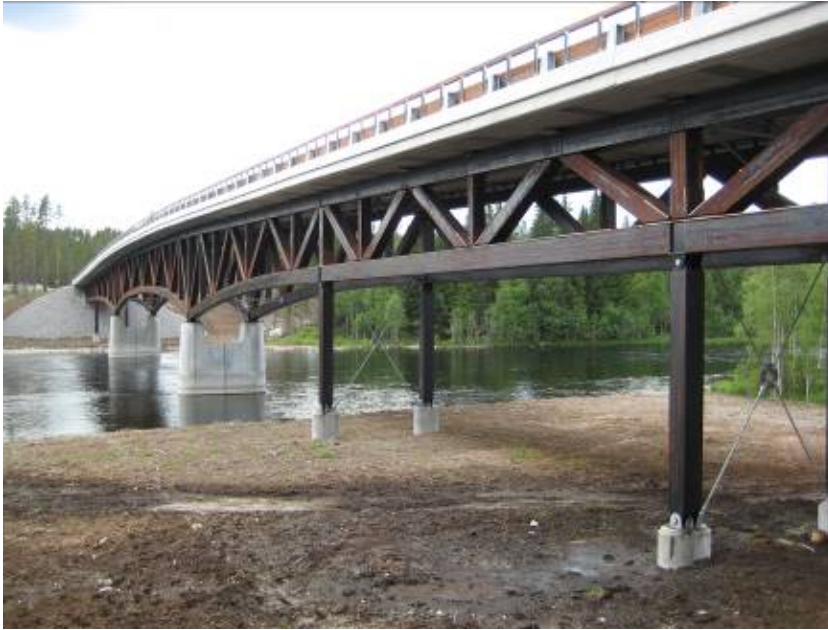
Figure 5: Norway – Military Road Bridge with concrete deck

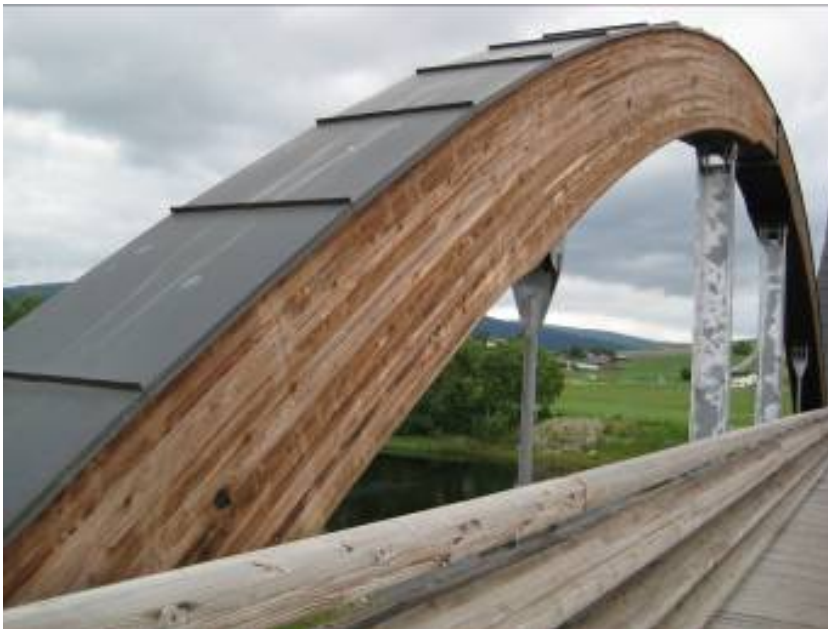
Figure 6: Showing typical detailing of main arch and parapets in Norway

The Norwegian bridges generally rely on two horizontal glulams block-glued together for the main arch members (Figure 6). Joints are formed using multiple flitch plates with 12mm steel dowels. Such connections are based on those developed by Moelven for the Winter Olympic halls at Hamar and Lillehammer. For the bridges, the plates are inserted in full depth slots, to allow any water which might enter the joint to escape (Figure 7).

The Norwegian bridges are designed for an 80 year life, which is achieved through a combination of a bitumen membrane on the deck, capping to end grain and horizontal surfaces (Figure 6) and preservation (both before gluing with a water based preservative, combined with creosote impregnation of the finished glulam). In recent bridges capping has also been introduced to diagonal members, due to the development of fissures in the upper surface of the diagonals. Preservation of the individual laminates is intended to provide protection in the event of water penetration into deep fissures. Monitoring has shown that the internal moisture content of the members and deck generally reaches 10-12% after 1-2 years, considerably lower than the predicted equilibrium moisture contents for the climates in question, although the reason for this is not yet fully understood. As a consequence only a partial downgrade on the dry E value is taken in serviceability calculations. Where the members are too large for a creosote treatment tank, sacrificial protection (louvres) are instead used to protect the vertical faces (Figure 9). Capping is generally omitted to members which are easy to inspect and replace such as the plan bracing.

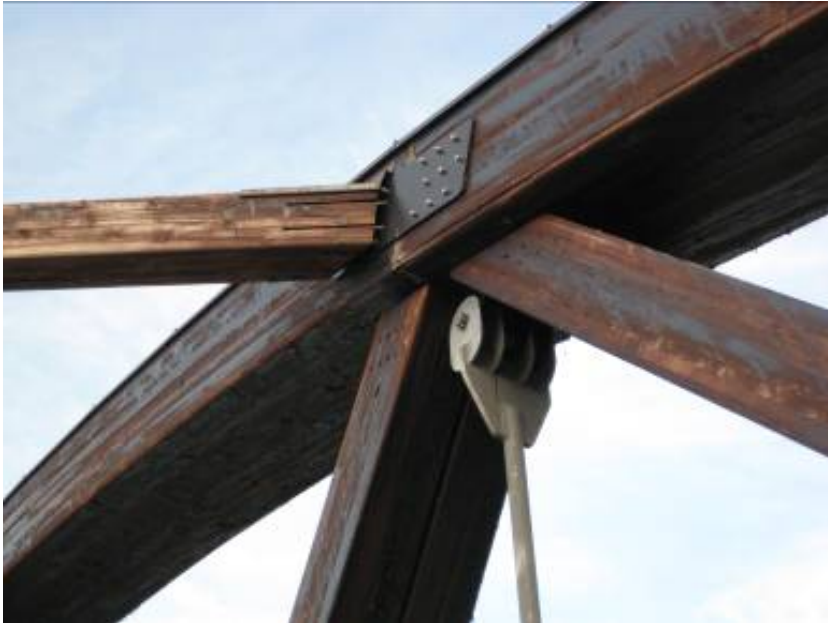
Figure 7: Typical connection detailing

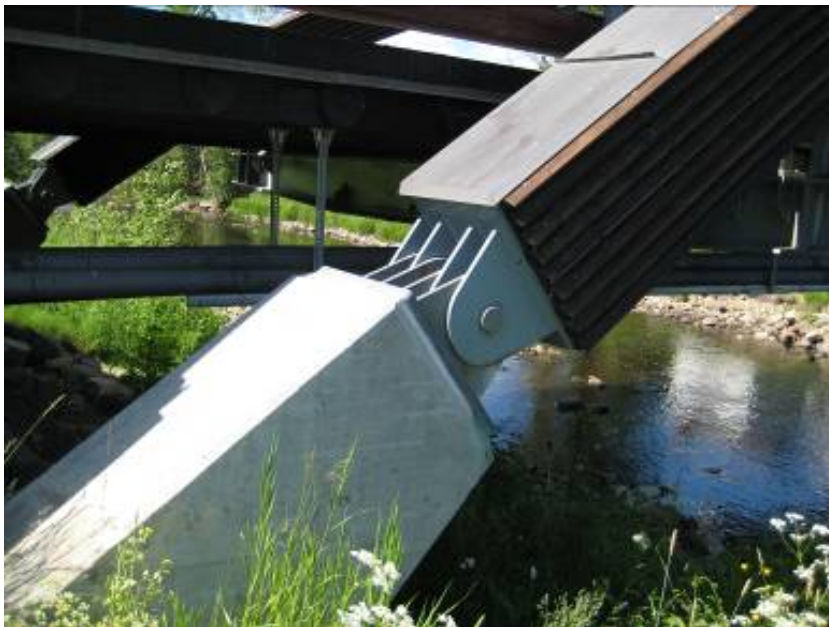
Figure 9: Where members are too large for the treatment tank, full physical protection is provided

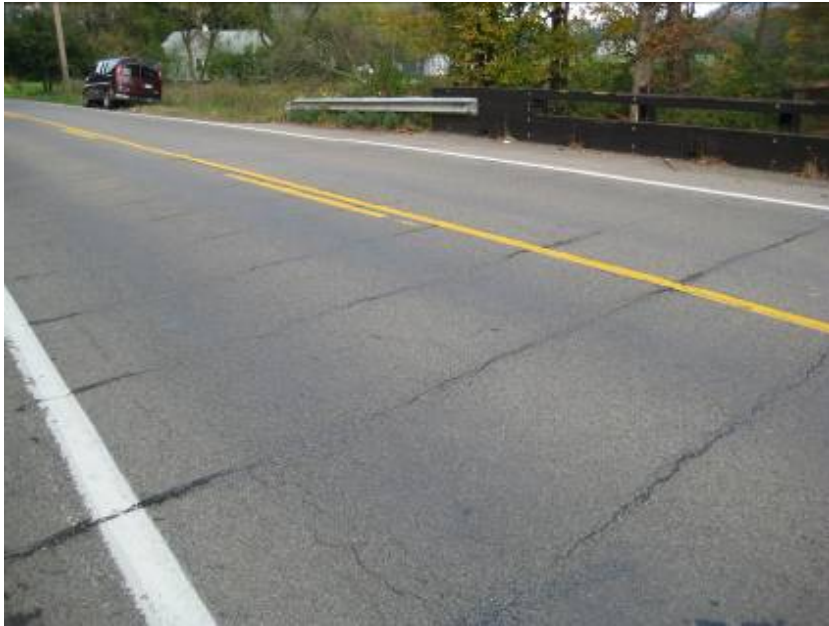
Figure 10: Cracking to wearing surface over joints between glulam deck panels

Both the Norwegian and American bridges exhibited cracking to the wearing surface. In the American bridges with glulam panels this generally occurred at the joints between the panels (Figure 10), even where stiffeners had been introduced to promote load sharing, and thus seemed to be primarily related to omission of the membrane leading to wetting of the upper surface of the deck causing hogging; hogged panels will deflect under load leading to cracks at the panel joints.

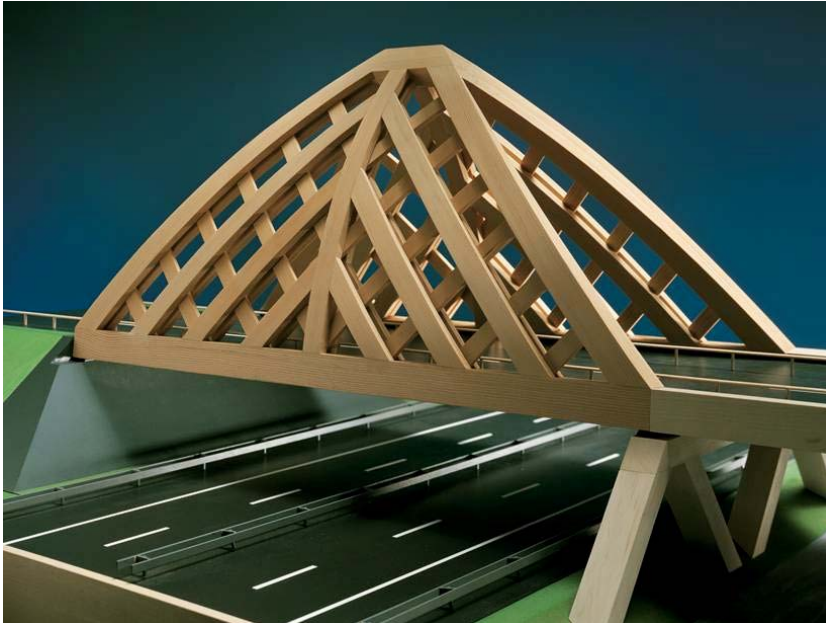
Figure 11: Model of acetylated timber bridge under construction in Holland

This relies on replacement of the water within the cell walls with acetyl groups (derived from acetic acid). The process is most effective with used on a permeable timber such as Radiata Pine (in which full depth penetration can be achieved on 100thk members). Long term field tests suggest better than Class 1 durability, and very low moisture movements because the timber is swelled back to its green volume during treatment and thus little further swelling is possible. Commercial production started in March, with a single facility in Holland although more are planned. Two 40m span roadbridges are also under construction using the material (Figure 11).

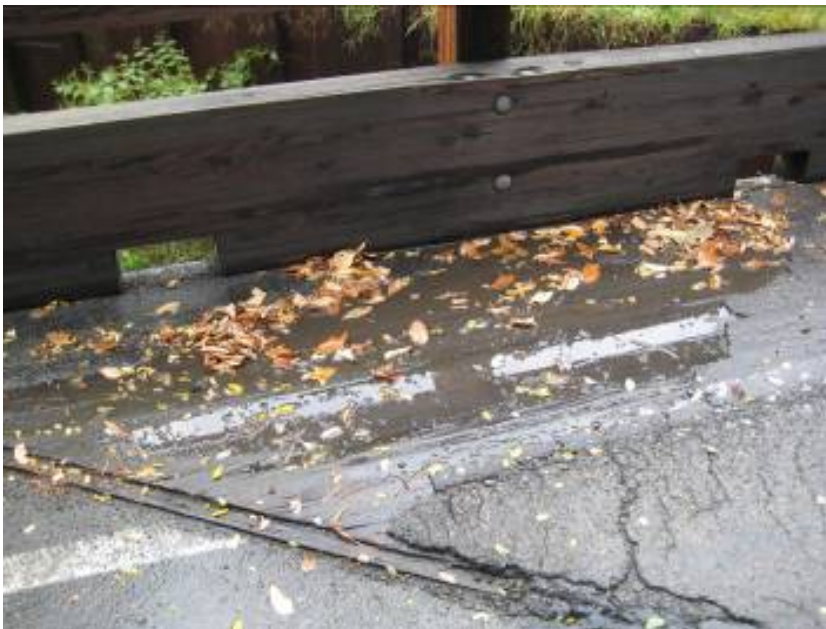
Figure 12: Omission of membrane and poor maintenance allow ponding on the glulam deck panels

In the USA, limited visual inspections are carried out every 2 years. There is also a move to start including intrusive inspections and long term remote monitoring to check for internal decay. While some counties have high standards of maintenance and inspection (eg: field treating any fissures), in other counties blocked outlets and water ponding on the decks (Figure 12) and suggest that little or no maintenance is being undertaken.
