Investigation of timber bridges

Alar Just
Tallinn University of Technology
Tallinn, Estonia

During this research, inspections on 17 timber bridges in Estonia were conducted by authors of this paper in the autumn of 2014. The study was ordered by the Estonian Road Cluster and was performed by SP Technical Research institute of Sweden and Tallinn University of Technology.

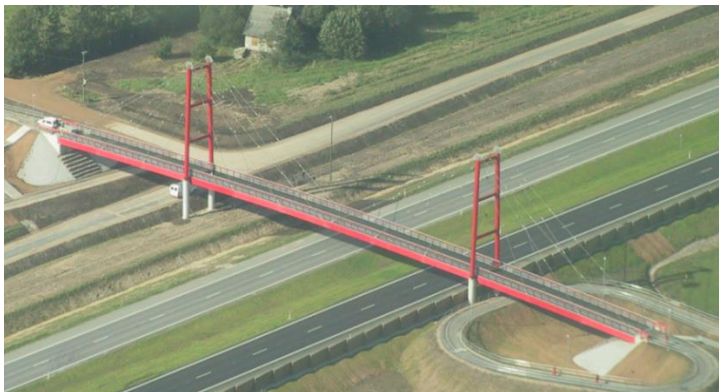
Figure 1: Vaida footbridge

Inspection showed that the bridges' superstructure is in fair to poor condition. Six of the glulam members in the girders were in poor condition and should be replaced. The moisture content was very high in the beams below the deck plate. Most of the glulam beams had just minor fungal decay, isolated to the upper 100-300 mm of the beam. Deck was seriously damaged by fungal decay along the edges. Part of the deck was completely rotten and collapsed. See Figure 4.

Year of construction	2008
Total length	124m
Practicable width	4m
Span length	31+62+31m
Type of structure	Cable-stayed bridge
Timber Beams and Deck:	not impregnated Spruce;
Pylons:	pressure impregnated Comwood of Spruce
Vertical eigenfrequency	2,4 Hz

Recovering of damages of the bridge should consist of the replacement of deck structure and replacement of at least two glulam beams (hit by the collapse). The bridge owner – Estonian Road Office – decided to demolish this bridge and build a new steel-concrete bridge instead.

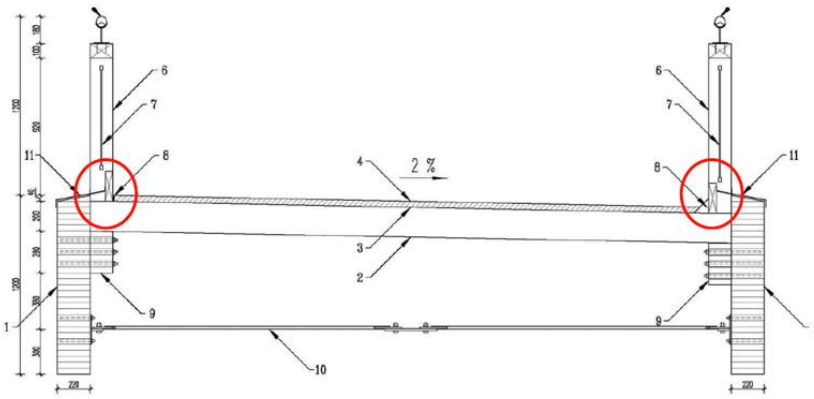
Figure 2: Section of the bridge.

The damage was caused by non-ventilated joints between deck plate and main girder. Deck was covered by water tight layer and asphalt. In contradiction with the designed solution, the support area at the edges of wooden deck plate was also covered by asphalt and the drying of wood of the deck plate at the edges was blocked. The water barrier shown in red in Figure 3 was missing.

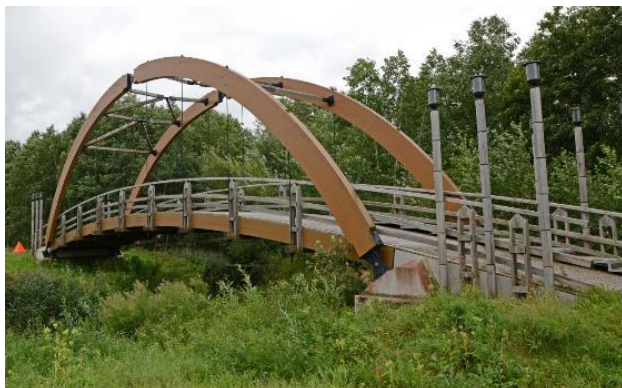
Figure 5: Reopalu footbridge.

The bridges' superstructure is in very good condition. There is no cladding, sheet metal or other wood protection on the arches or other parts of the super structure. The moisture content in the glulam, is very high close to the bearings, over 25%. The moisture content will remain very high until all weather exposed parts are covered with cladding.

The paint on wooden parts is in poor condition on the south sides. See Figure 6.

During the inspection the poor maintenance has been recorded. At the supports there were dirt and gravel as well as vegetation discovered close to the timber load bearing elements. With some preventative maintenance, the bridge will be in excellent condition.

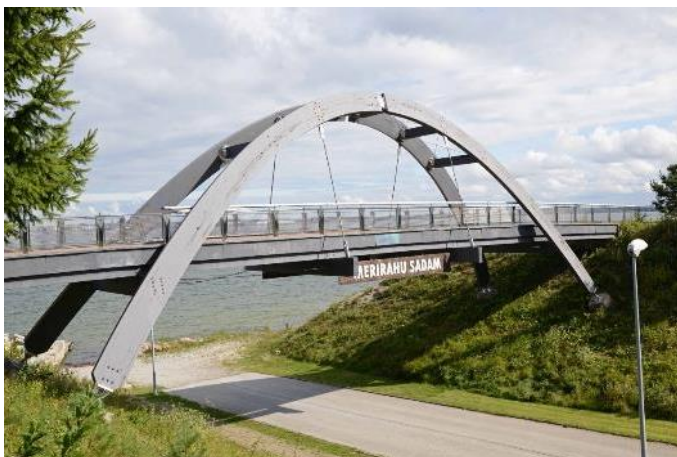
Figure 8: Merirahu footbridge.

Merirahu footbridge is an arch bridge with span of 24,5 meters. Bridge has a balcony on the sea side. Main structural elements are covered by five layers of alkyd paint. Bridge deck is covered by bitumen emulsion and gravel layer. All the steel elements of this bridge are made of stainless steel. Main characteristics of the bridge are shown in Figure 8. The bridge was repainted with a dark paint on 2010. Author of this paper do not have information about the chemical content of the paint.

The inspection discovered that the bridges' superstructure was in a serious condition. Probably the dark colour of the new paint led to cracks and allowed the water insertion into the wood. Drying of wood was blocked and that led to development of fungal damage in the arches and cross-beams.

The most critical damage is severe decay and deformation in one transversal beam. The beam was considered as fracture critical during the inspection. The transversals condition is beyond corrective action due to decay in connecting points and along the upper quarter of all sides. See Figure 10.

Condition of two arches was beyond corrective action due to decay at supports. The arches were in fair to poor condition and the south east side was recommended to be replaced. The moisture content was high, 20-24% and the decay process could continue until the arches are covered with cladding. The arches are made of spruce. These problems could have been avoided with chemically treated arches and/or protective cladding.

The deck was in fair to poor condition. It's a nail laminated deck made of surface treated spruce covered with a thin bitumen layer with washed gravel on top. The deck should have been made of treated pine instead of spruce. The bitumen layer was too thin, and damaged, to protect the deck. Lack of preventive maintenance was also discovered.

The condition of the top followers of the railing was also beyond corrective action due to decay by fungi. The deck had some spots with minor decay. All wood parts were made of spruce (*Picea Abies*) instead of chemically treated Pine (*Pinus Silvestris*). The use of spruce instead of a more durable material in weather exposed bridge elements may shorten the service life.

The bridge owner decided to repair the bridge in 2017.

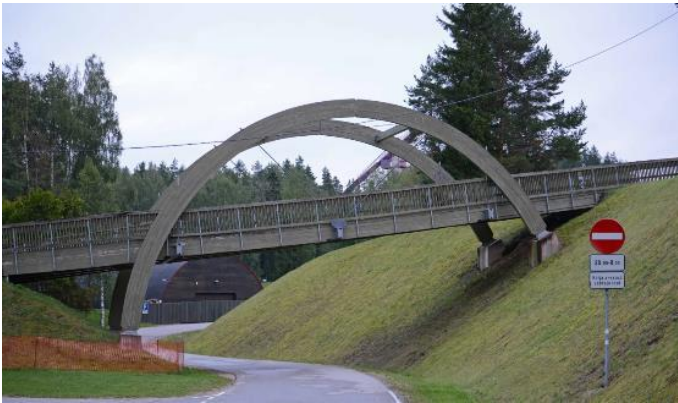
Figure 11: Tehvandi rollerski bridge.

Tehvandi wooden bridge is an arch bridge with length of 24,5 meters. Bridge is built for rollerski track. Main structural elements are made of pressure impregnated pine. Deck is made of solid wood and covered by asphalt pavement. Main characteristics of the bridge are shown in Figure 11.

Generally, the bridge is in good conditions. The owner of the bridge made maintenance on 2016 consisting re-painting of the bridge and cleaning the abutment areas.

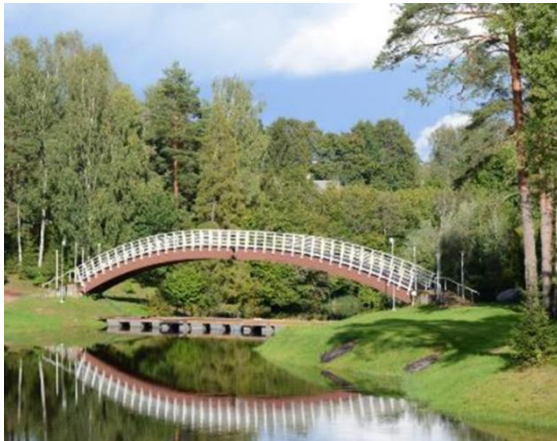
Figure 13: Tõrva footbridge.

Tõrva footbridge is an arch bridge with span of 38 meters. Age of the bridge is about 30 years. Bridge elements are not impregnated nor covered by claddings. The bridge has currently the longest span among timber bridges in Estonia. Main characteristics of the bridge are shown in Figure 13.

The owner of the bridge made a renovation of the bridge at 2016 consisting making new larger steel plates to extend arch top and foot connections to the undamaged wood.

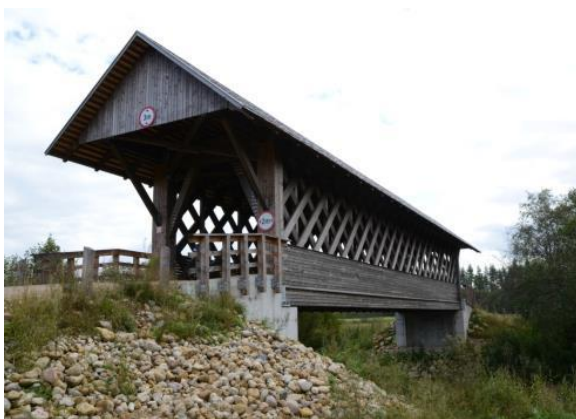
Figure 16: Järuska covered bridge.

Year of construction	2013
Total length	26,4m
Practicable width	3,5m
Type of structure	Truss bridge
Timber	not impregnated Spruce (Picea Abies)
Vertical eigenfrequency	9,5Hz
